4 WTC 4, 5, and 6

4.1 Design and Construction Features

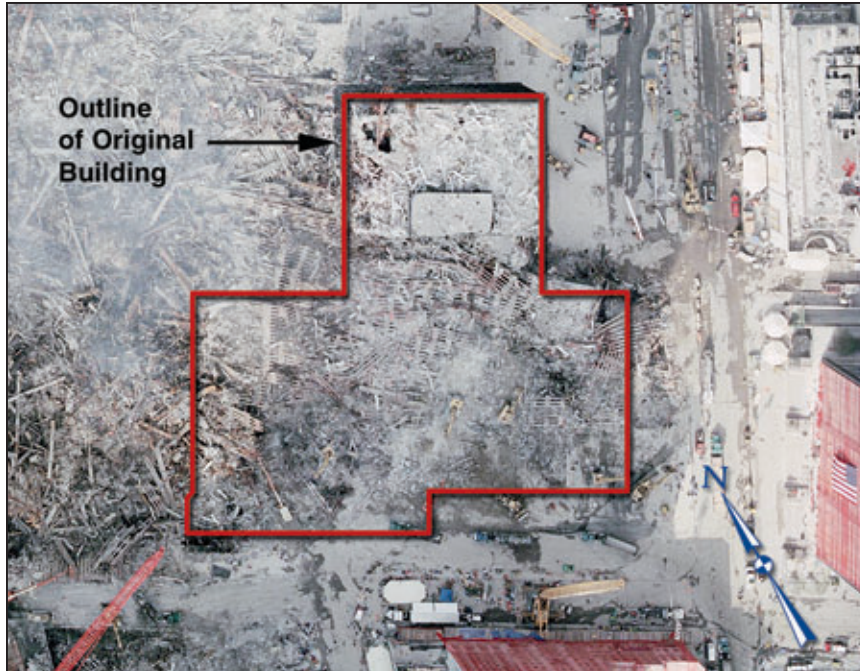
There was major impact to WTC 4 from the collapse of one or both of the twin towers (most likely WTC 2) that destroyed all but the northern 50 feet of the building. Extensive damage is evident in Figure 4-5.

Figure 4-5
Damage to WTC 4.

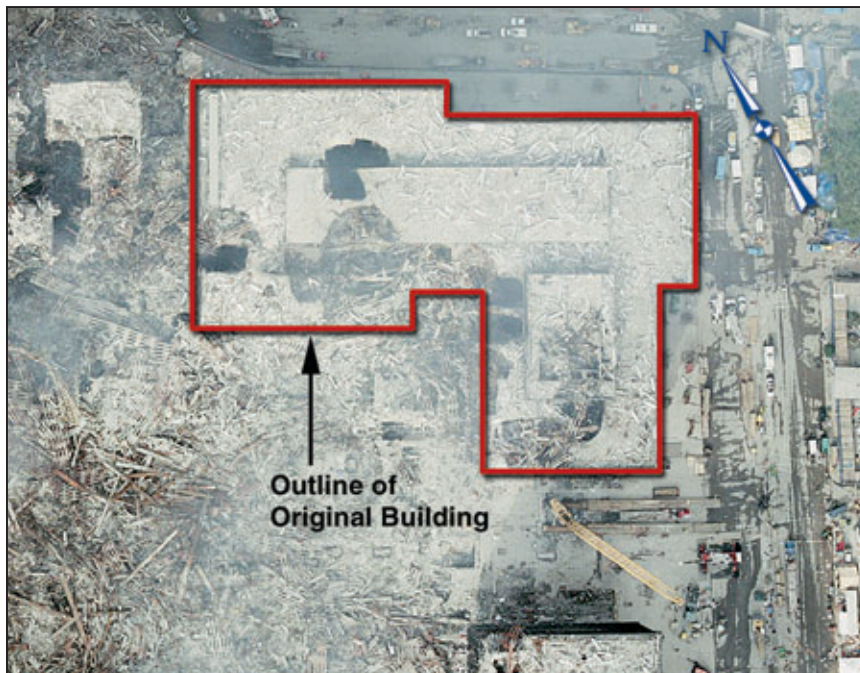
WTC 5 was damaged by impact and subsequent fires. The impact damage areas in WTC 5 are shown in Figure 4-6. The debris damage caused localized collapses from the roof to the 3rd floor in most of the areas where exterior columns impacted the structure. Ensuing fires that burned unchecked in the building caused a localized collapse from the 9th floor to the 4th floor. Figure 4-7 diagrammatically shows the damaged and collapsed areas of WTC 5 due to impact and fire.

Figure 4-6
Damage to WTC 5.

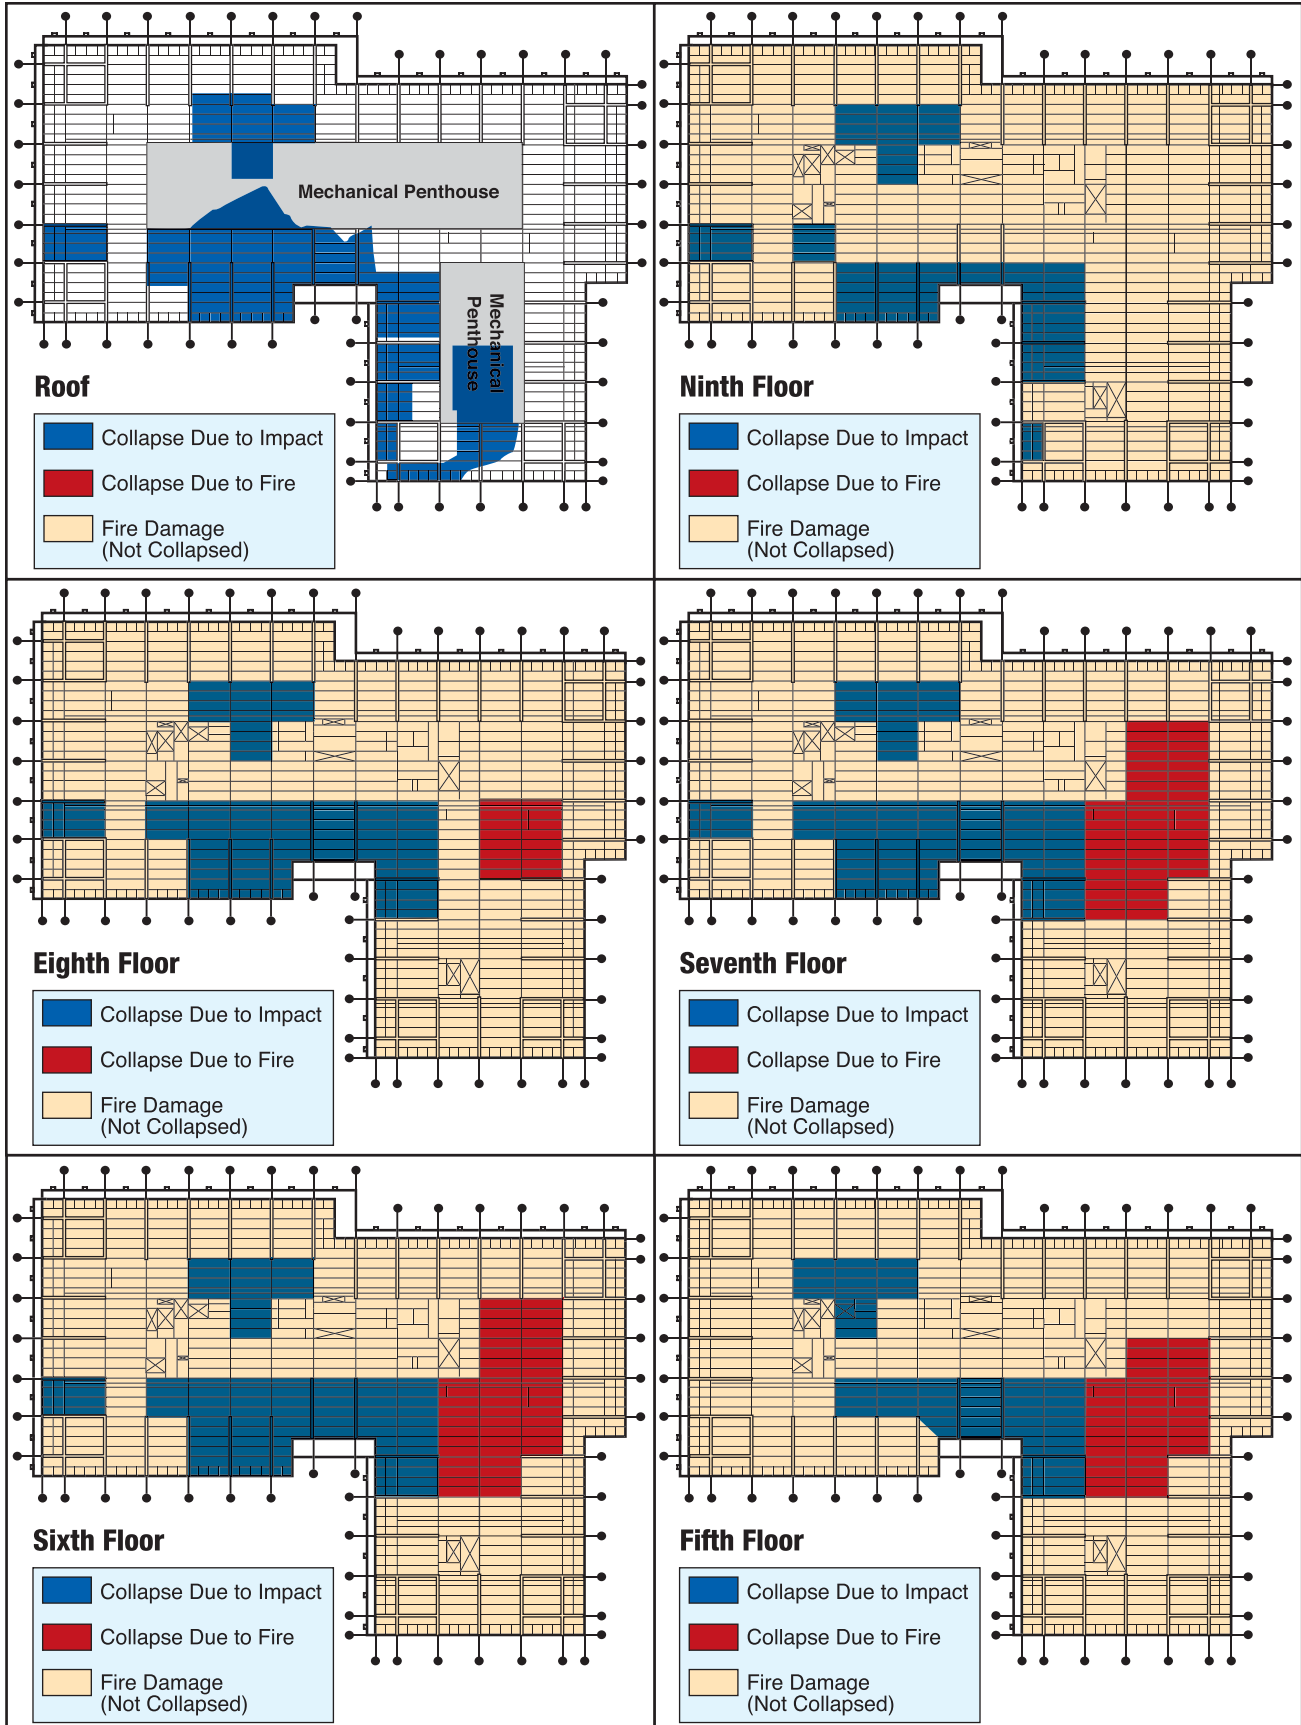
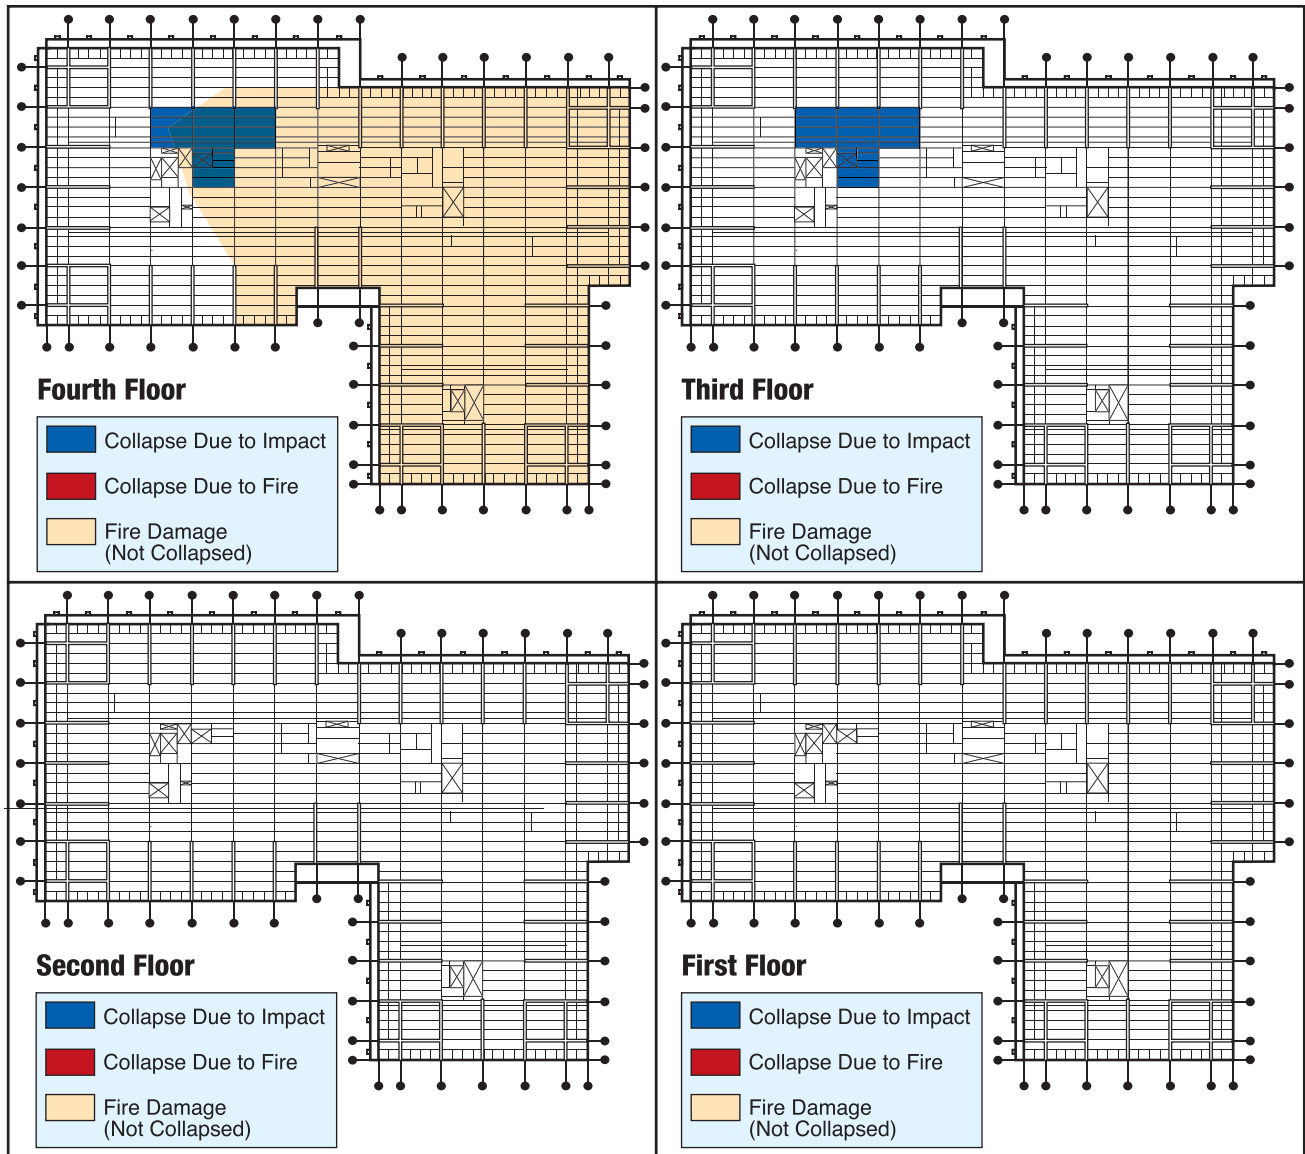
Figure 4-7 Approximate locations of damaged floor areas in WTC 5.

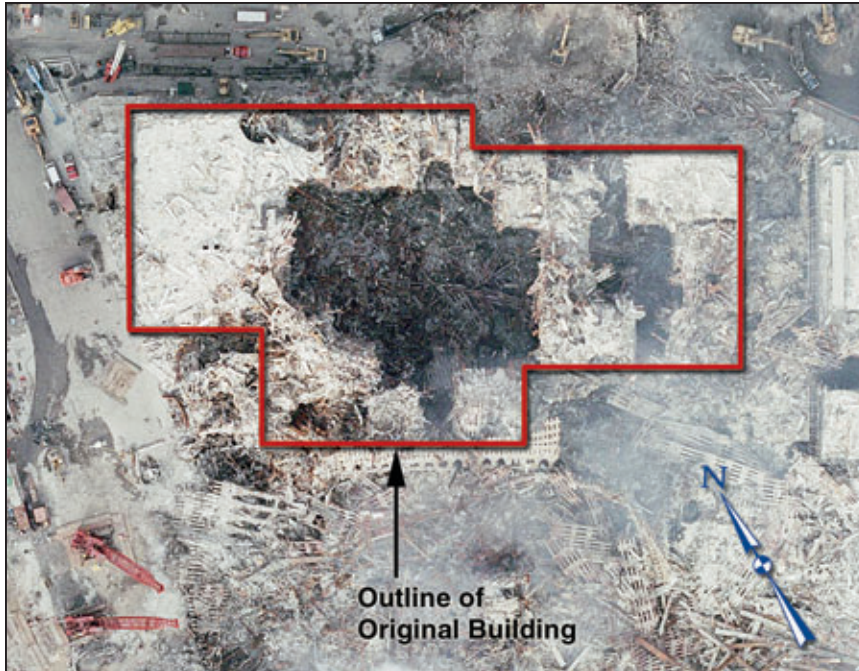
WTC 6 suffered significant impact and fire damage from the collapse of WTC 1, as shown in Figure 4-8. Most of the impact appears to have been in the center of the building, where the damage extended to the ground level. Figures 4-9 and 4-10 illustrate the magnitude of the damage.

Figure 4-8
Damage to WTC 6. Note the edge of
WTC 5 on the right hand side.

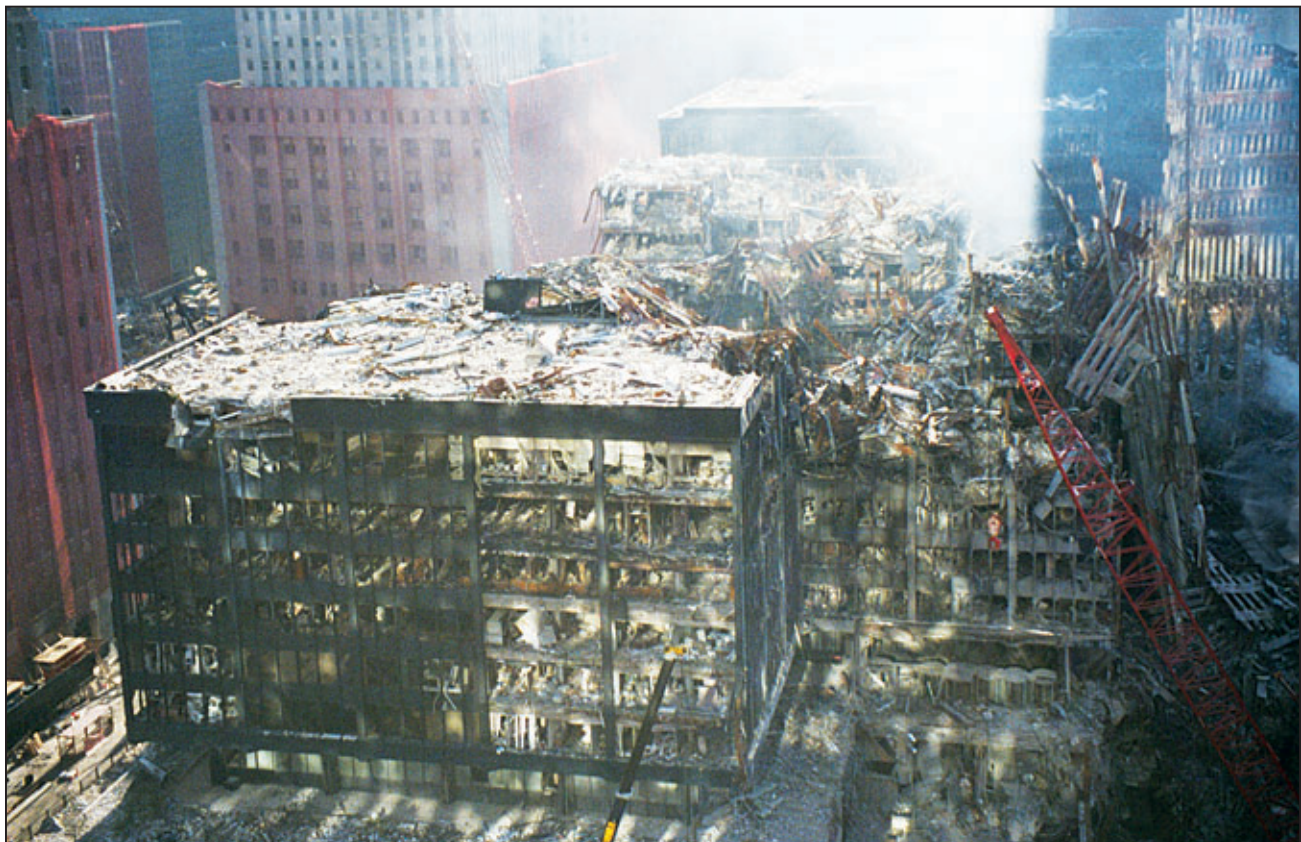
Figure 4-9 Impact damage to WTC 6.

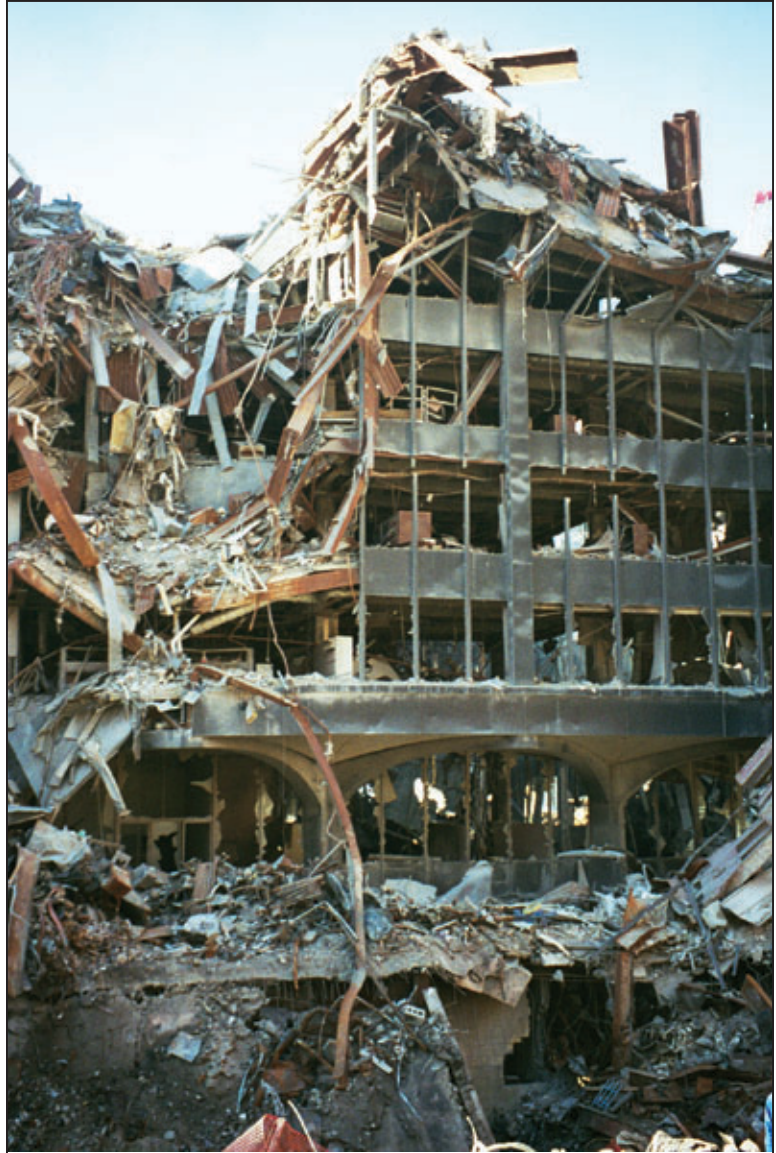
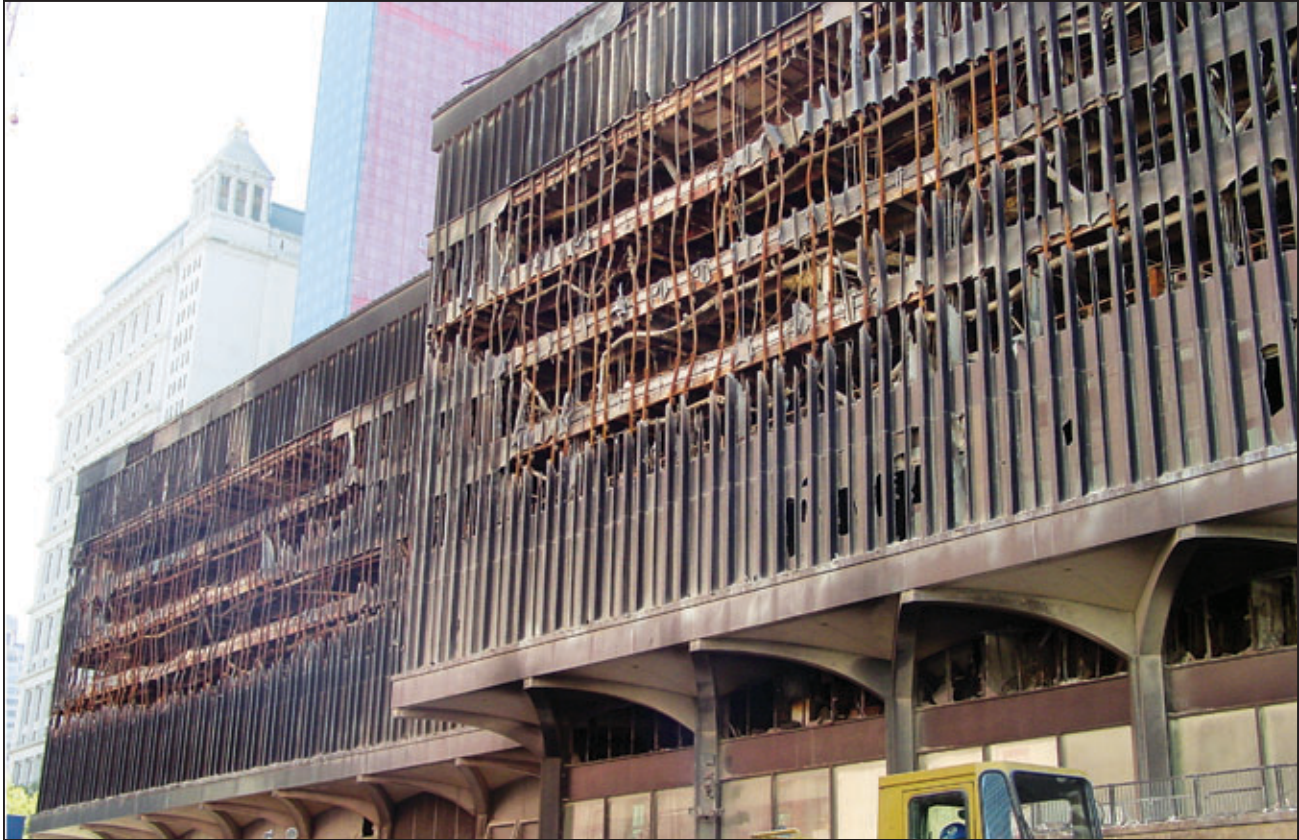
Many areas of buckled steel-beam flanges appeared to have been caused by debris impact. There were 3-1/2 inch steel pipe façade supports along the building perimeter, many of which had buckled from taking part of the collapsed floor loads above the pipe supports (see Figure 4-11). In areas that locally collapsed from impact, some of the floor beams separated from the floor deck and others separated at the welded connection.

Figure 4-11 WTC 5 façade damage.

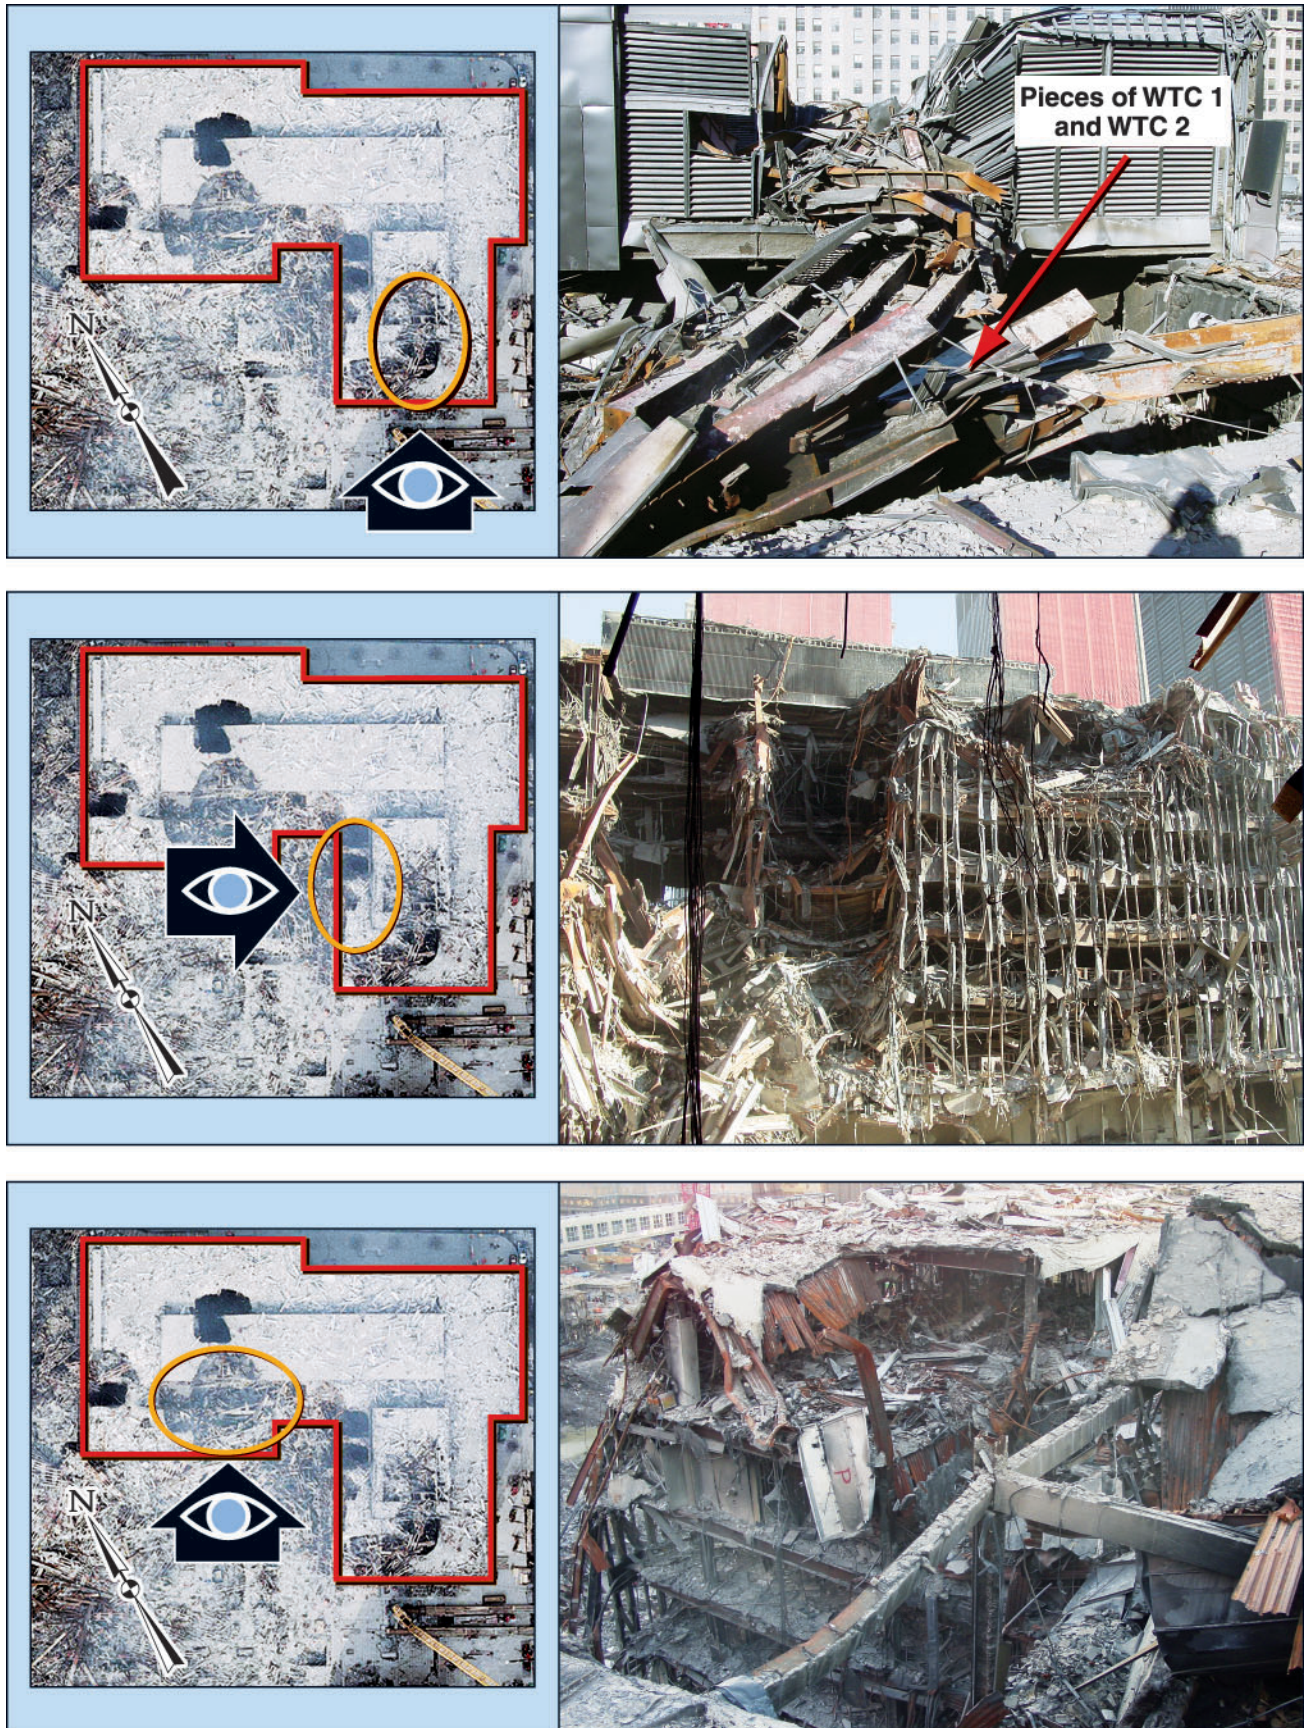
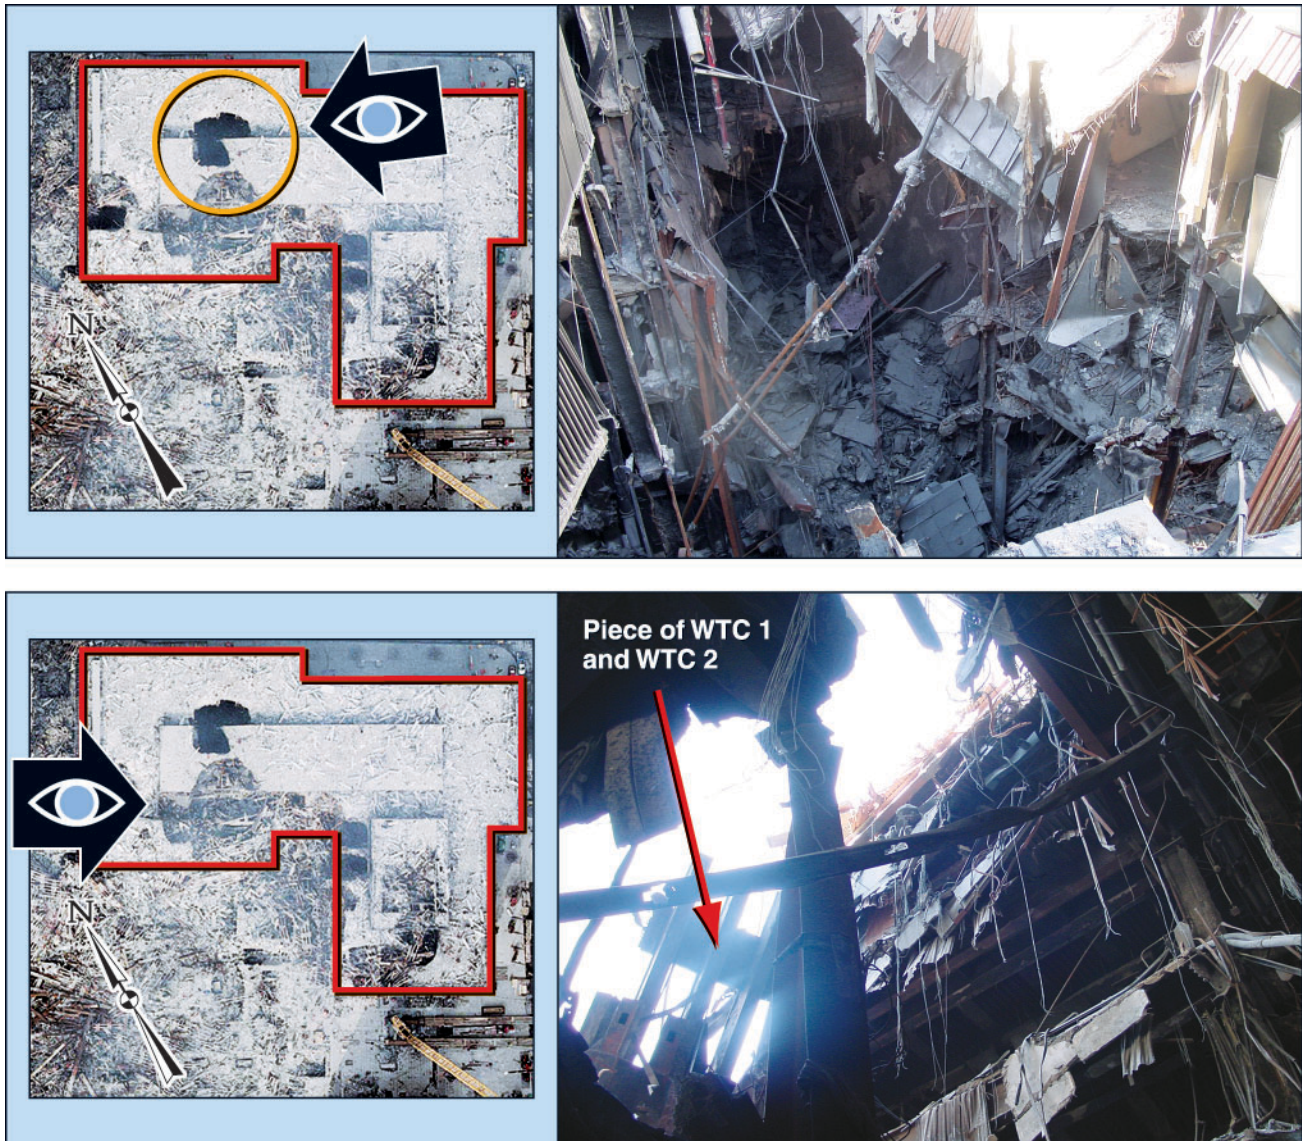
Significant impact damage to WTC 5 is shown in Figure 4-12. The damage was concentrated on the west side of the building.

Figure 4-12 Impact damage to WTC 5.

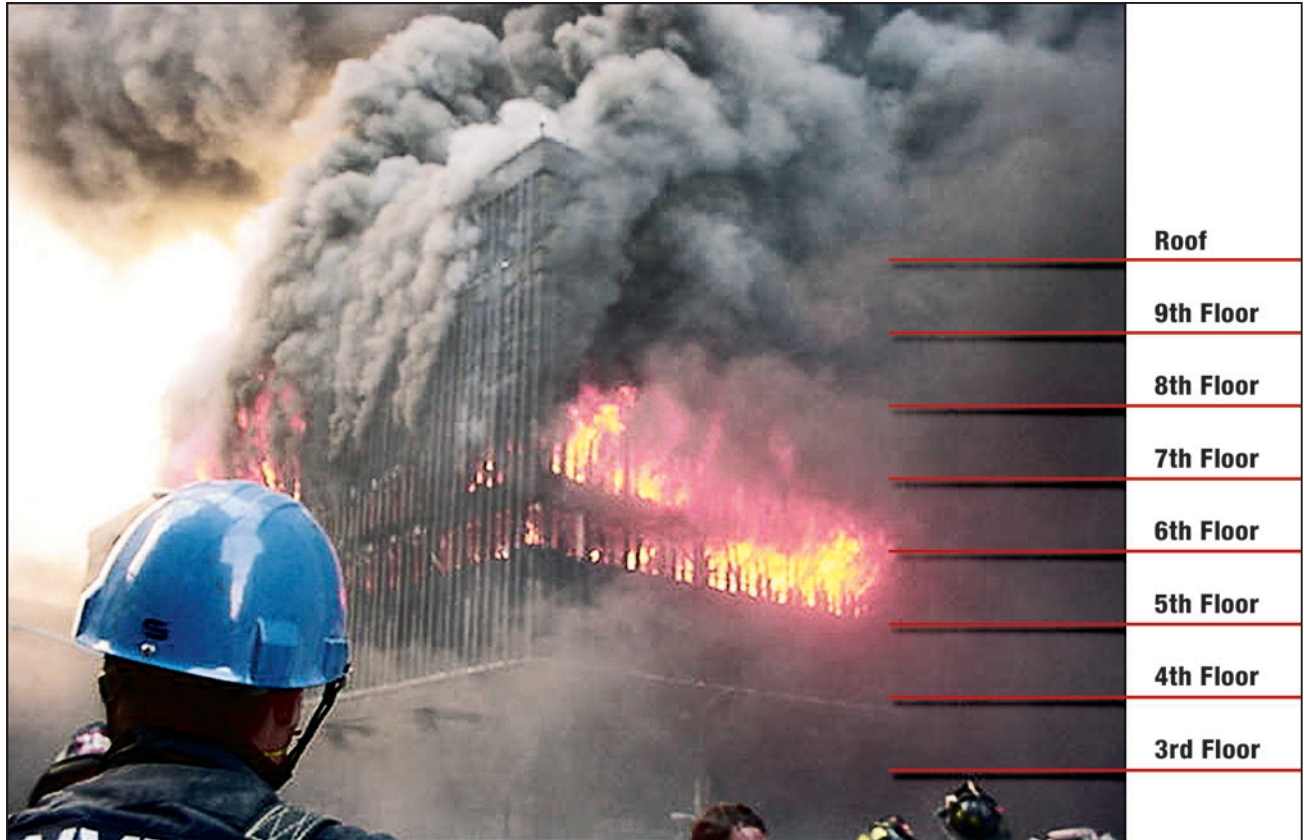
Figure 4-13 shows WTC 5 on fire. The source of ignition has not been identified. It is likely that it was due to flaming debris entering the building from WTC 1 and WTC 2. There was a complete burnout of all combustibles from the 5th floor and above. Some steel beams supporting the roof were deformed due to the heat, as illustrated in Figure 4-14, and some local buckling occurred as well. Roof tar entered the floor through the drains. There is no indication that this roof tar played a major role in the fires. One area below the roof at the 8th floor collapsed onto the 7th floor and then both onto the 6th, and so on, down to the 4th floor.

Figure 4-13 WTC 5 on fire.

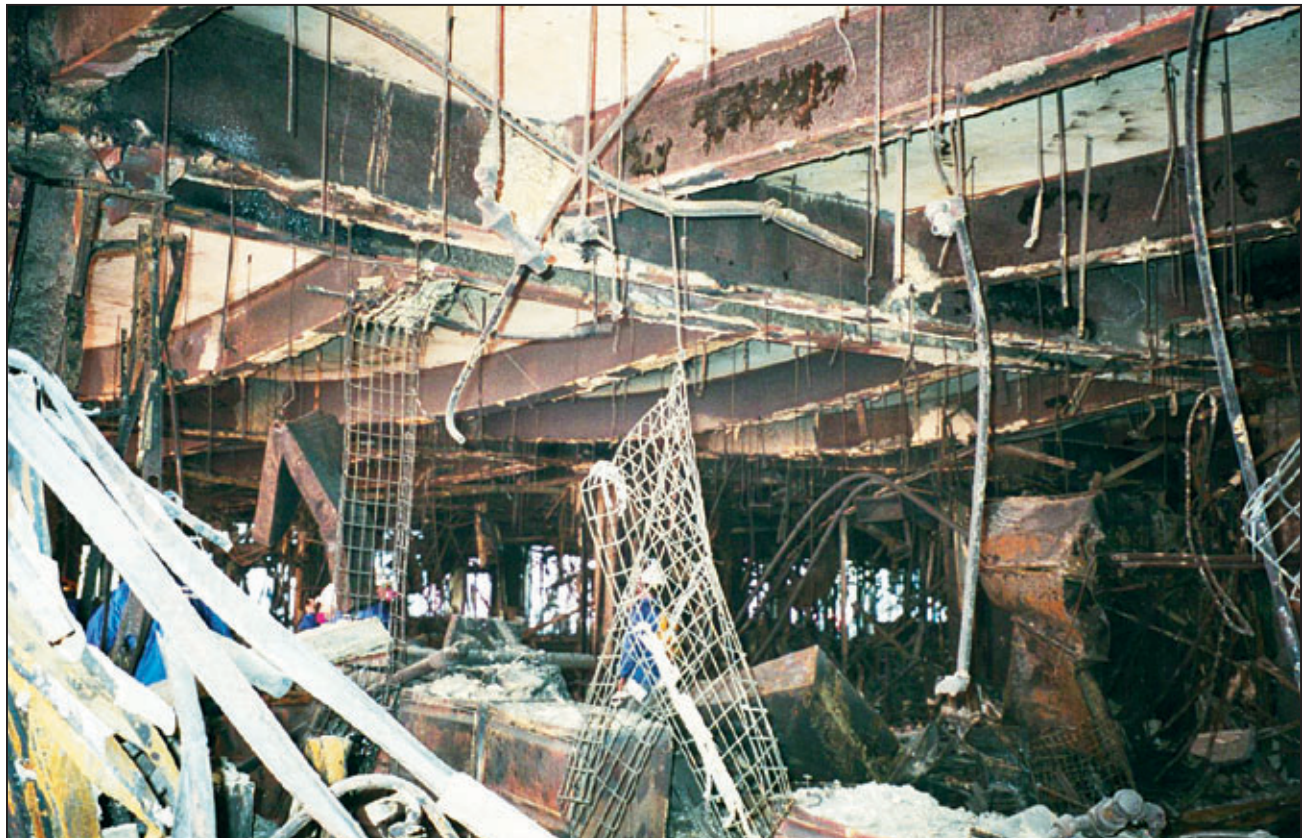
Figure 4-14 Deformed beams in WTC 5.

The steel generally behaved as expected given the fire conditions in WTC 5. Many beams developed catenary action as illustrated in Figure 4-14. Some columns buckled, as shown in Figure 4-17. The one exception is the limited internal structural collapse in WTC 5. The fire-induced failure that led to this collapse was unexpected. As in the rest of the building, the steel beams were expected to deflect significantly, yet carry the load. This was not the case where the beam connections failed. The failure most likely occurred during the heating of the structure because the columns remained straight and freestanding after the collapse.

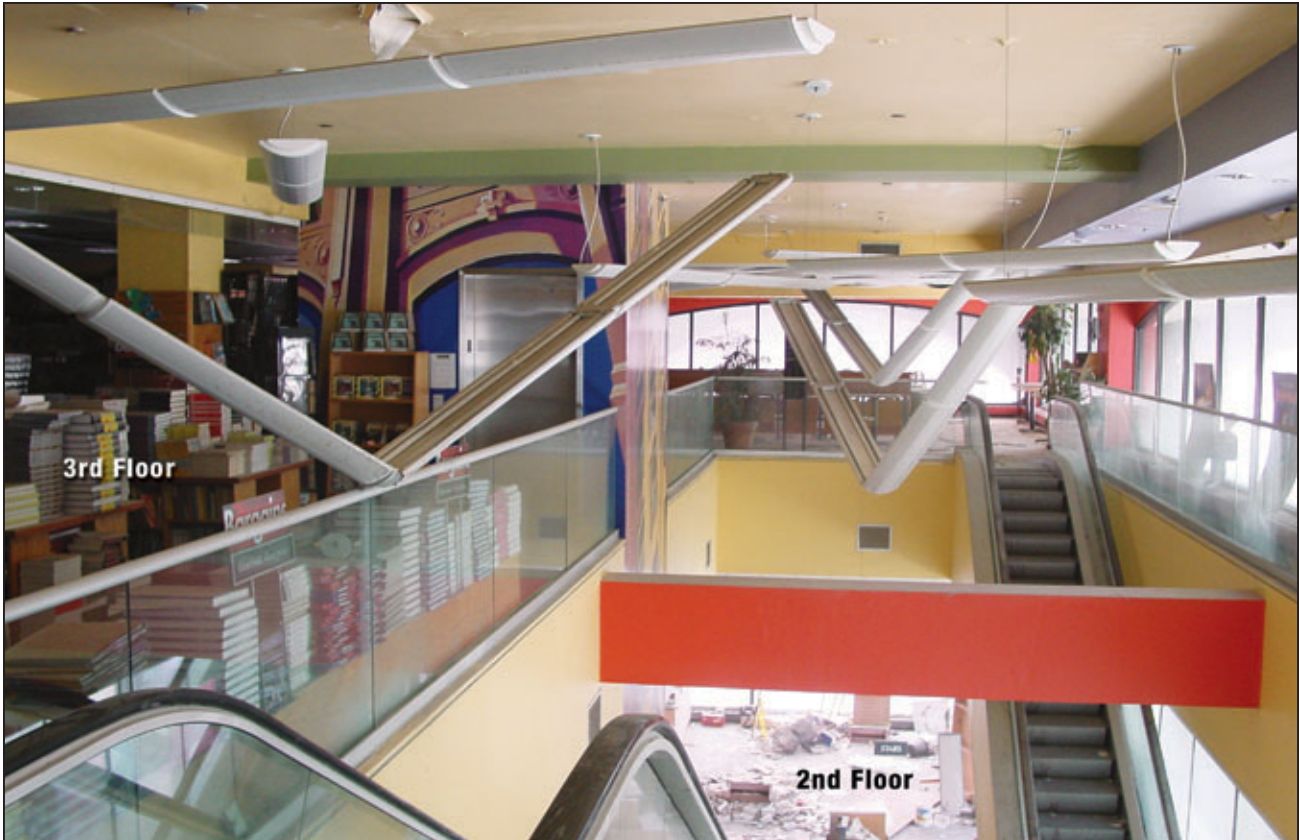
The sprinkler system appears not to have operated at all. This was evident due to the lack of water damage throughout, but especially in the lower level bookstore shown in Figure 4-15. Many sprinkler heads were damaged; some even melted and fell off the sprinkler piping in the fire areas.

Figure 4-15 Unburned bookstore in WTC 5.

The automatic sprinkler system did not control the fires. Some sprinkler heads fused, but there was no evidence of significant water damage, due to a lack of water. This is consistent with the lack of water damage in the bookstore on the lower level and the complete burnout of the upper floors.

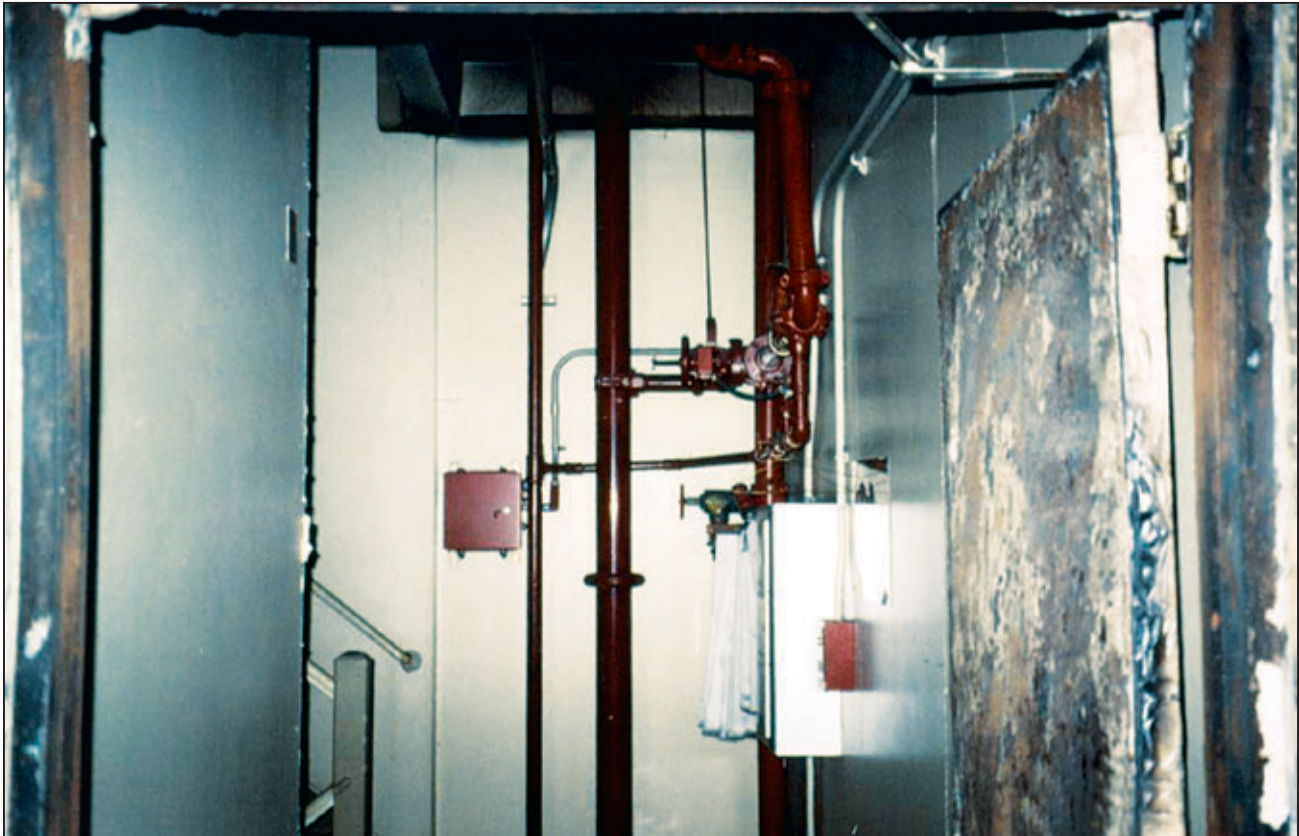
As illustrated in Figure 4-16, the interior of the exit stair tower at the southwest corner was practically untouched by the fire. There were no burn marks or smoke damage in this exit tower, or on the “safe” or stairwell side of the fire door. At one location, a piece of paper was found taped to the exit stairwall just inside the fire door with no evidence of smoke or charring from fire.

Figure 4-16 Looking through the door into the undamaged stair tower in WTC 5.

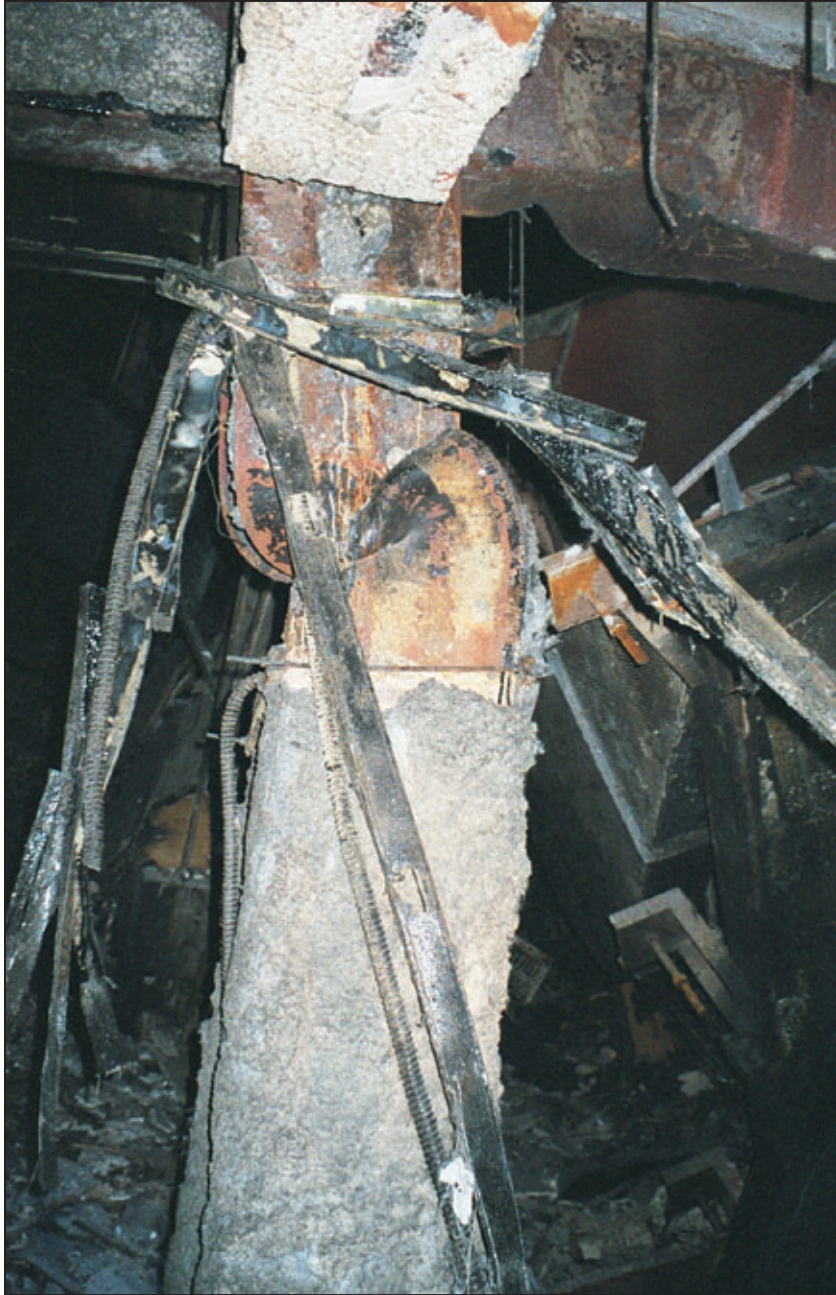
As illustrated in Figure 4-17, there was local buckling of interior columns. This buckling was most likely due to a combination of fire-induced reductions in strength and a possible increase in stress due to restrained thermal expansion. A detailed explanation of these issues is presented in Appendix A, Section A.3.1.4.

*Figure 4-17
Buckled beam flange and column on the
8th floor of WTC 5 that was weakened by
fire.*

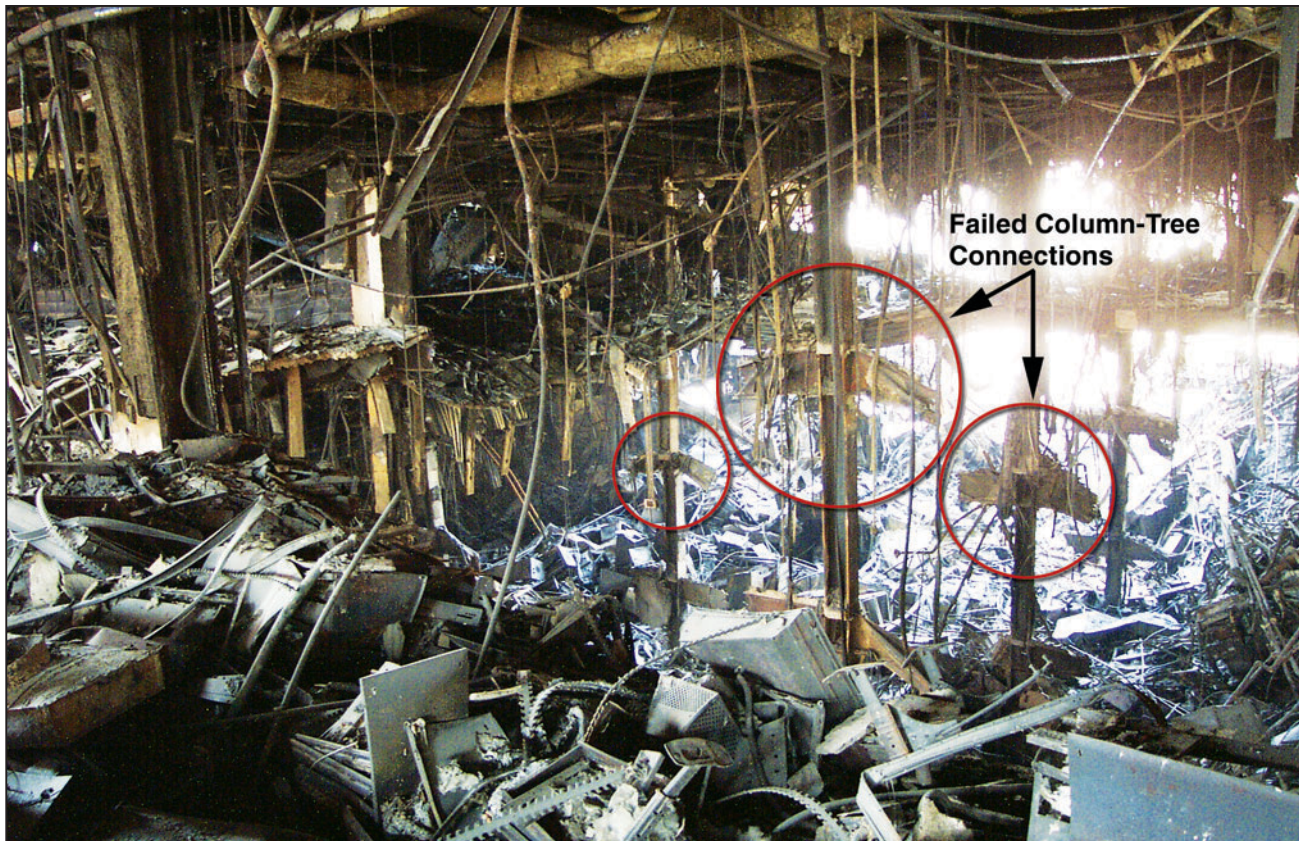
The structural collapse appeared to be due to a combination of excessive shear loads on bolted connections and unanticipated tensile forces resulting from catenary sagging of the beams. The existence of high shear loads, likely due to collapsing floor loads from above, was evident in many of the column-tree beam stub cantilevers that formed diagonal tension field mechanisms in the cantilever webs and plastic moments at the column, as seen in Figure 4-18.

It is apparent that fire weakened the steel, contributing to the large shear-induced deformations observed in several of the cantilever beams. The shear failures observed at connection ends in several of the beam web samples shown in Figure 4-18 are indicative of the tensile forces that developed. The end bearing resistance of the beam web was found to be less than the double shear strength of the high-strength bolts, based on the analysis presented in Appendix B.

Figure 4-18 Internal collapsed area in WTC 5.

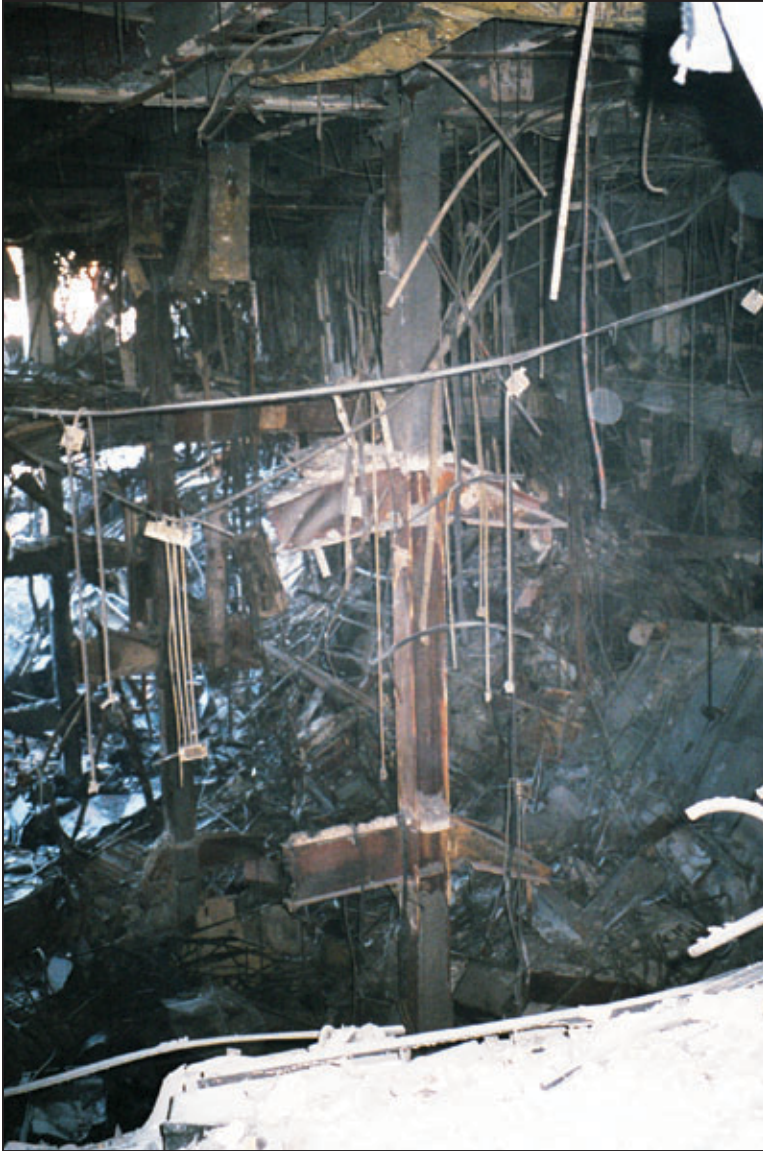
Figure 4-19
Internal collapsed area in WTC 5.

The limited structural collapse in WTC 5 due to fire impact as described in Section 4.3.2 appeared to be caused by a combination of excessive shear loads and tensile forces acting on the simple shear connections of the infill beams. The existence of high shear loads was evident in many of the column tree beam stub cantilevers that formed diagonal tension field failure mechanisms in the cantilever webs, as seen in Figure 4-19.

The end bearing resistance of the beam web was less than the double shear strength of the high-strength bolts. An increased edge distance might have prevented this collapse by increasing the connections' tensile strength. The failure most likely began on the 8th floor and progressed downward, because the 9th floor did not collapse. The 4th floor and those below remained intact.

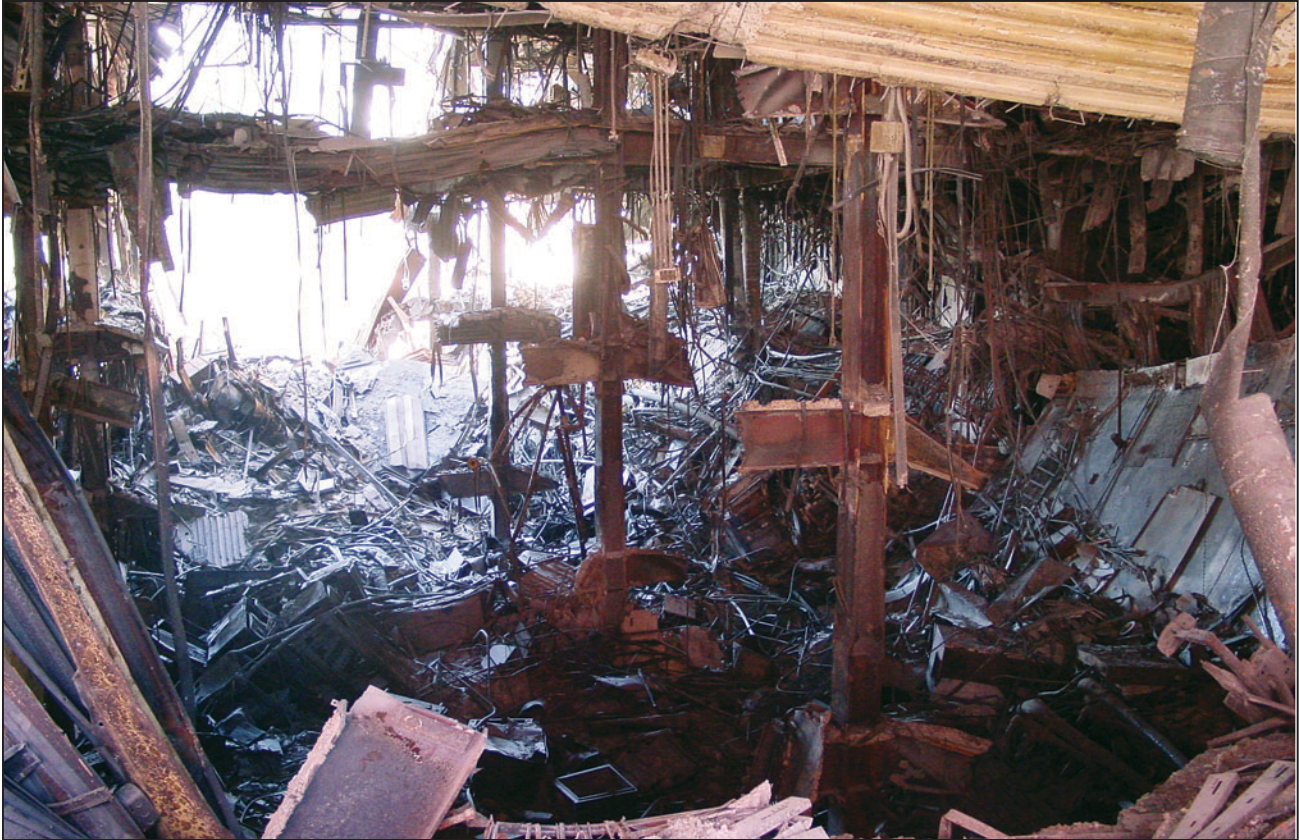
Two areas in WTC 5 experienced local collapse under an intact portion of the roof. Although there was debris impact near this area, the symmetrical nature of the collapse strongly suggests that the failures were due to the uncontrolled fires. This is supported by the observation that the columns in this area remained straight and freestanding (see Figure 4-18). This local collapse appeared to have begun at the field connection where beams were connected to shop-fabricated beam stubs and column assemblies as illustrated in Figures 4-19, 4-20, and 4-21.

Figure 4-20 Internal collapsed area in WTC 5.
